Rattle Noise From Tail Gate When Closing

Service Category Vehicle Exterior

Section Door/Hatch

YEAR(S)	MODEL(S)	ADDITIONAL INFORMATION
2024 - 2025	Tacoma, Tacoma HV

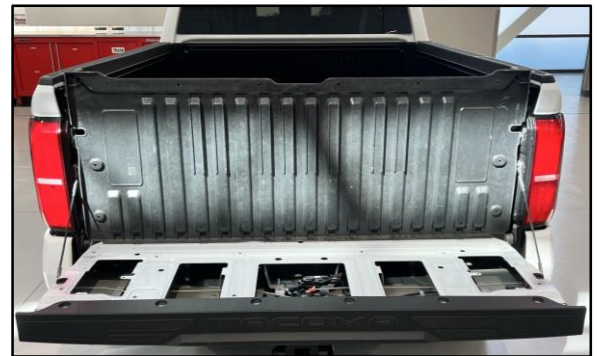
Figure 2. Tail Gate Service Hole Cover Lifted

4. Lift the tail gate service hole cover.

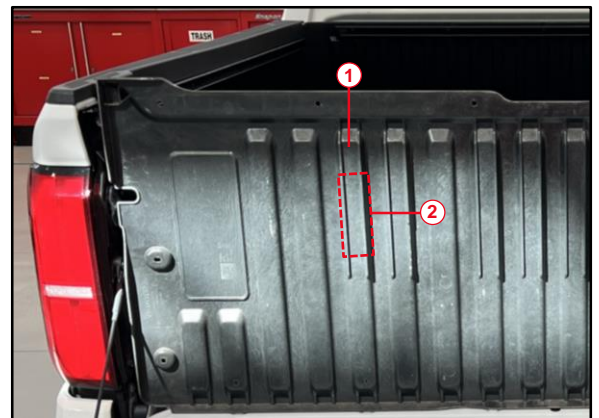
Figure 3.

1	Third Rib from the Top Left
2	Area to Clean

5. On the inside of the tail gate service hole cover, locate the third rib from the top left (see Figure 3).
 - A. Clean the center of the third rib with an alcohol wipe and let it dry.

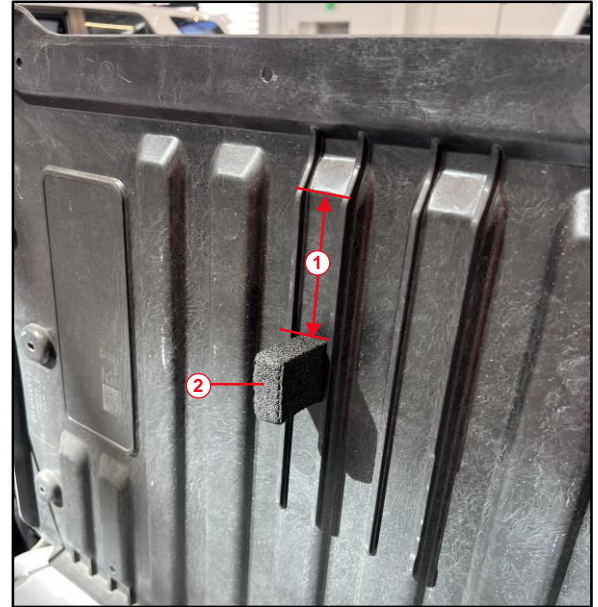
1	86 mm
2	Tail Gate Pad (65749-AK010)

- B. Start at the end radius of the third rib and measure down 86 mm. Apply the tail gate pad (65749-AK010) in the center of the third rib, as shown in Figure 4.
