Sloshing or Splashing Noise Caused by Water Inside Doors

Service Category Vehicle Exterior

Section Door/Hatch

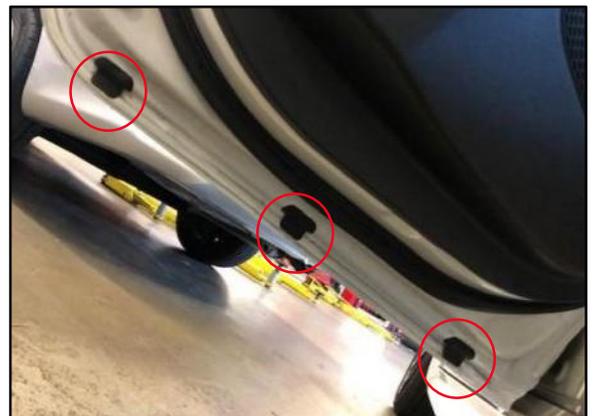
Figure 1. Dust Seal Location

1. Confirm the condition exists.
Does the vehicle exhibit a sloshing or splashing noise when turning at low speeds or when opening and closing doors?
 - **YES** — Continue to step 2.
 - **NO** — This bulletin does NOT apply. Continue diagnosis using the applicable Repair Manual.
2. Remove the dust seals from the bottom of each door and allow the water to completely drain.

This step should be applied to ALL doors regardless of which door is holding water.

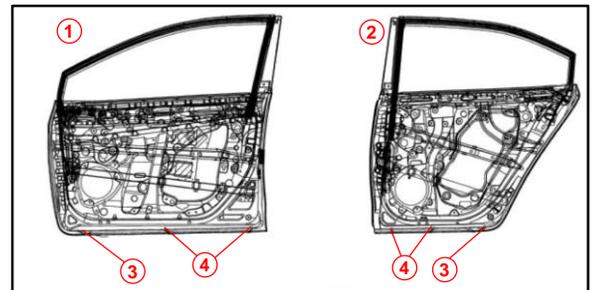
Figure 3.

1	Front Door
2	Rear Door
3	Dust Seal No Longer Required
4	Install Dust Seal

4. Clean the doors and reinstall the eight dust seals.
 - A. Once the water has completely drained from each door, wipe the bottom surface of the doors at each dust seal location to ensure no obstructions are present for installation.
 - B. Reinstall two dust seals per door at the locations indicated.

- The forwardmost dust seal is no longer required for the front doors.
- The rearmost dust seal is no longer required for the rear doors.

5. Discard the four dust seals that are no longer required and confirm the condition no longer exists.
